## ASP Kingman-Hualapai Unit

Evaluation Of Damage Following Disturbance  
Report Dated 7/7/15

**Evaluation of damage and adherence to ADOC Physical Plant Standards of ASP-Kingman,  
Hualapai Unit, following disturbance**

**Site visit on July 7, 2015**

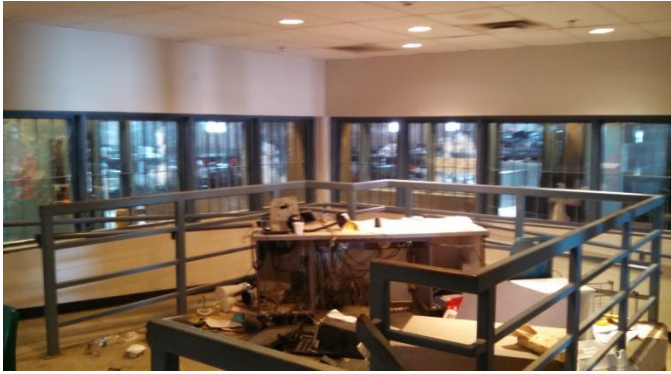
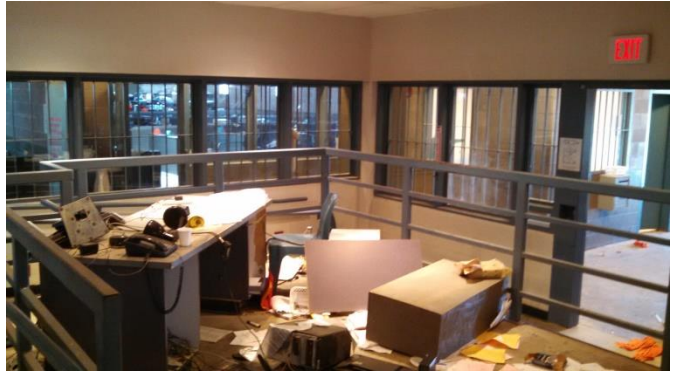
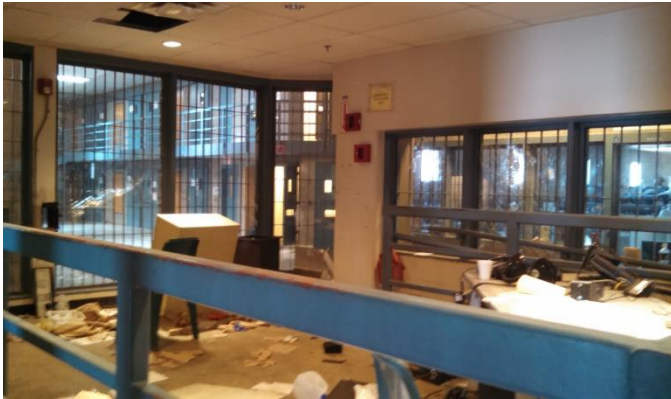
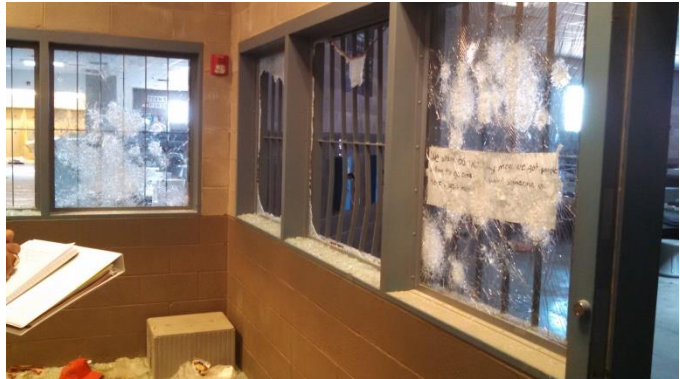
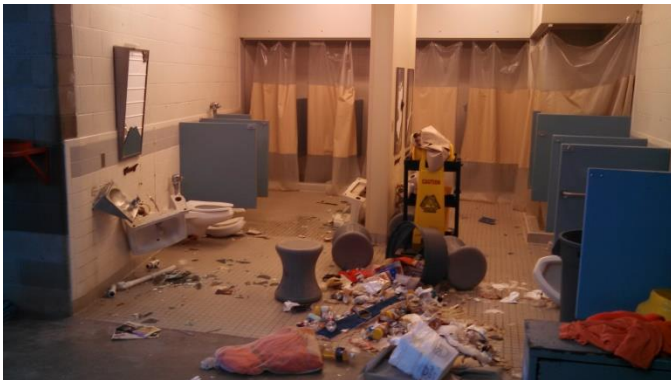
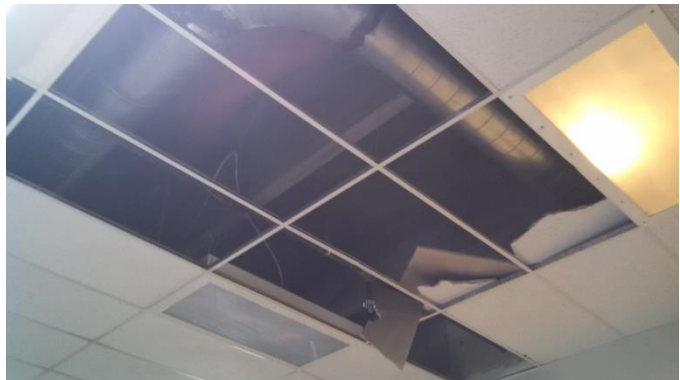
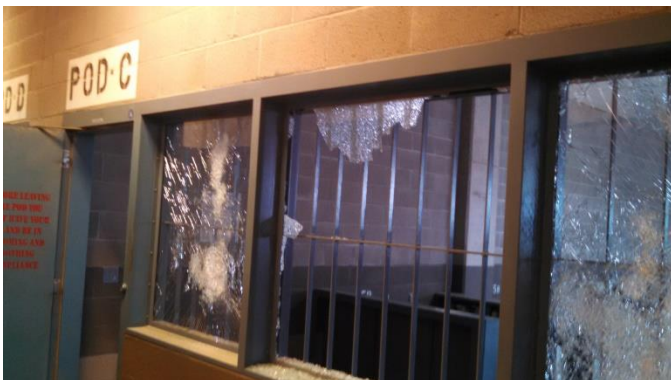
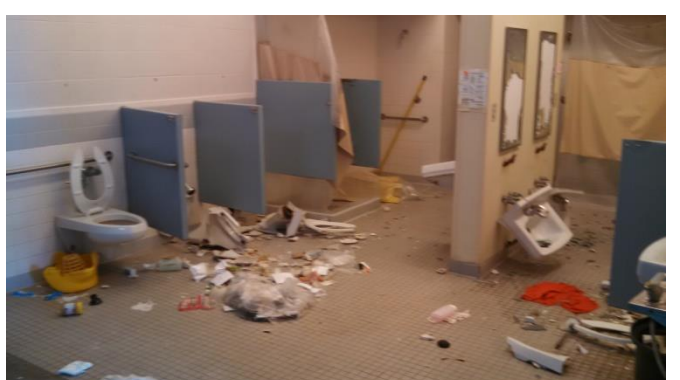
## Dormitory # 5

Dorm Control Rooms 5, 4 and 3 were destroyed including most of the Fire Alarm panels, and thermostats. Dorm 1 Control was the mostly heavily damaged outside including security bars (3 were bent away from the window and 2 were completely removed). Inmates were unable to gain access to the interior of Dorm 1.

Restroom facilities in each run had extensive damage with most porcelain toilets, urinals and lavatories (sinks) being broken and in some cases the restroom was completely destroyed. Heavy metal partitions in the showers were removed (with the grab bar still mounted) and were the principle device for inflicting the most damage. Almost every secure door into the individual Pods were bent beyond repair as the partition was used as a battering ram.

Since the heavy privacy panels from the showers were the main source of most destruction they should be removed and replaced with the plastic hanging type that is in the front of the shower.

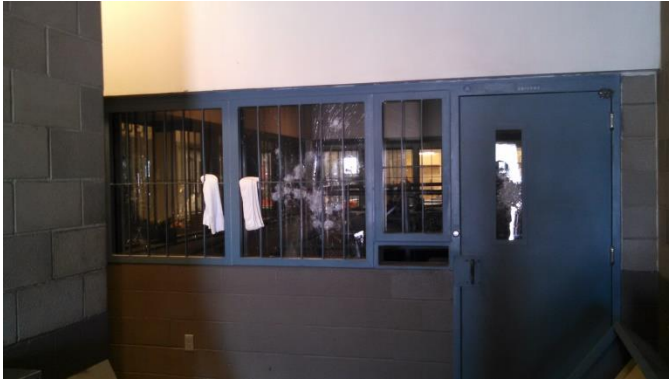
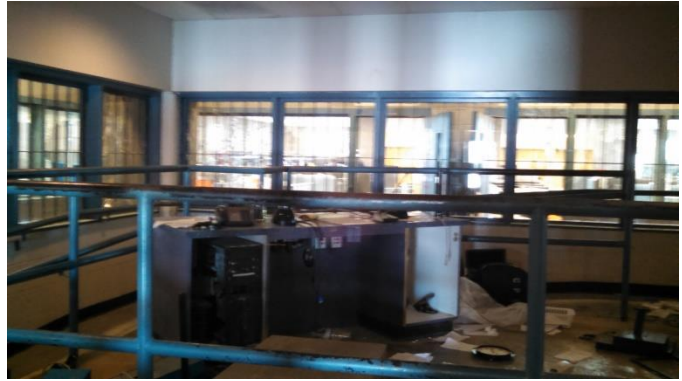
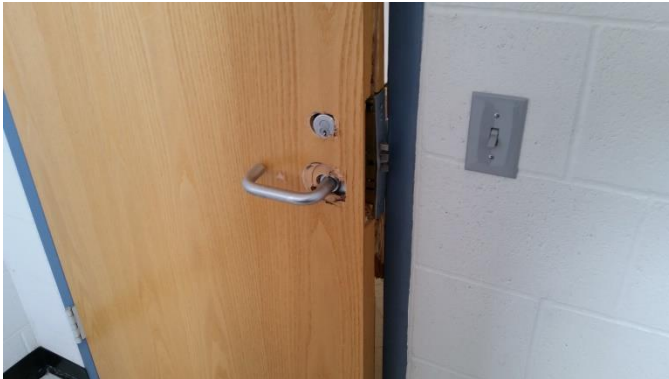
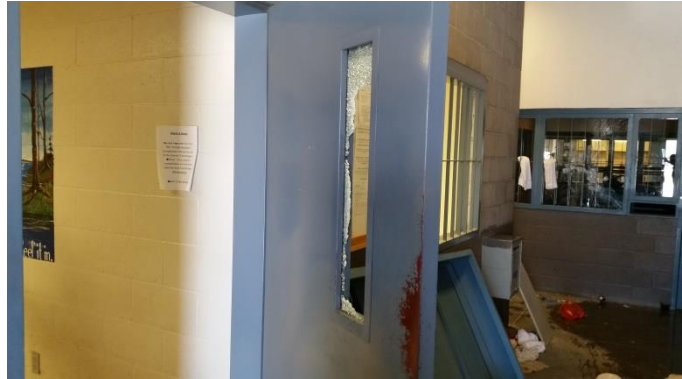
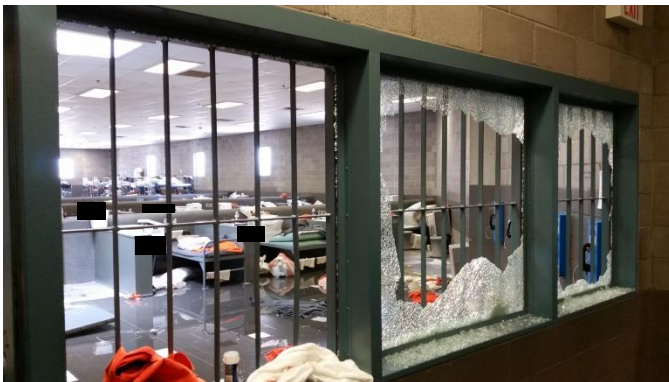
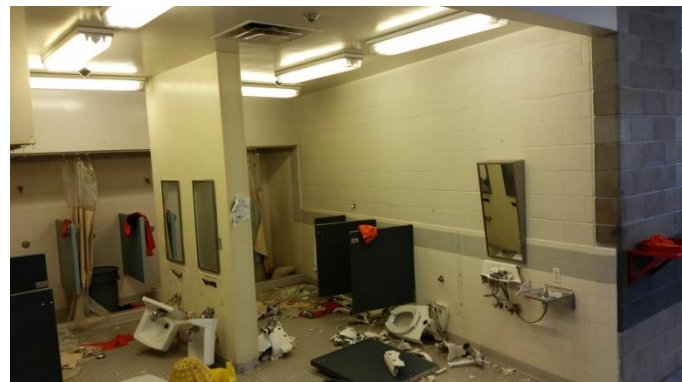
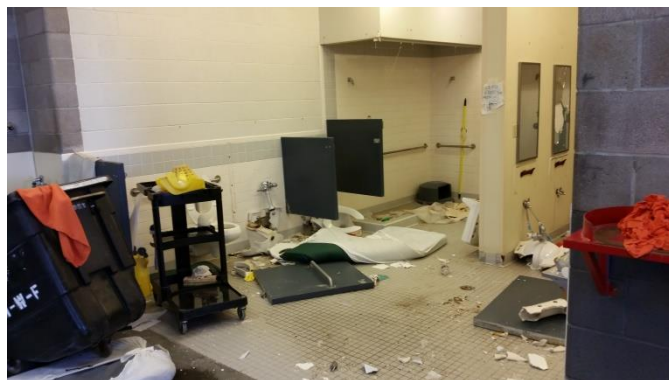
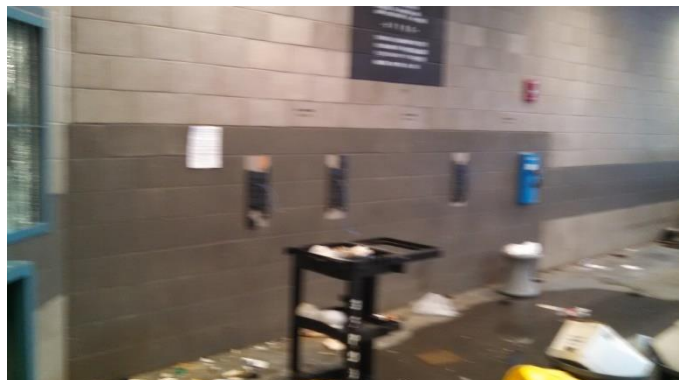
## Dormitory # 3

Inmate telephones were intact (inside the pods) with the exception of Dorm 3 Pod F 3 out of 4 were ripped off the wall.
